CAMDEN LOCAL PLANNING PANEL

SUBJECT: DA/2020/232 - ALTERATIONS AND ADDITIONS TO AN EXISTING HERITAGE BUILDING (GLEDWOOD HOMESTEAD) AND USE AS A CENTRE BASED CHILD CARE CENTRE - 900A CAMDEN VALLEY WAY, GLEDWOOD HILLS

**REMEDIAL ACTION PLAN
900 CAMDEN VALLEY WAY
GLEDSWOOD HILLS**

Hazardous Materials Audit Report

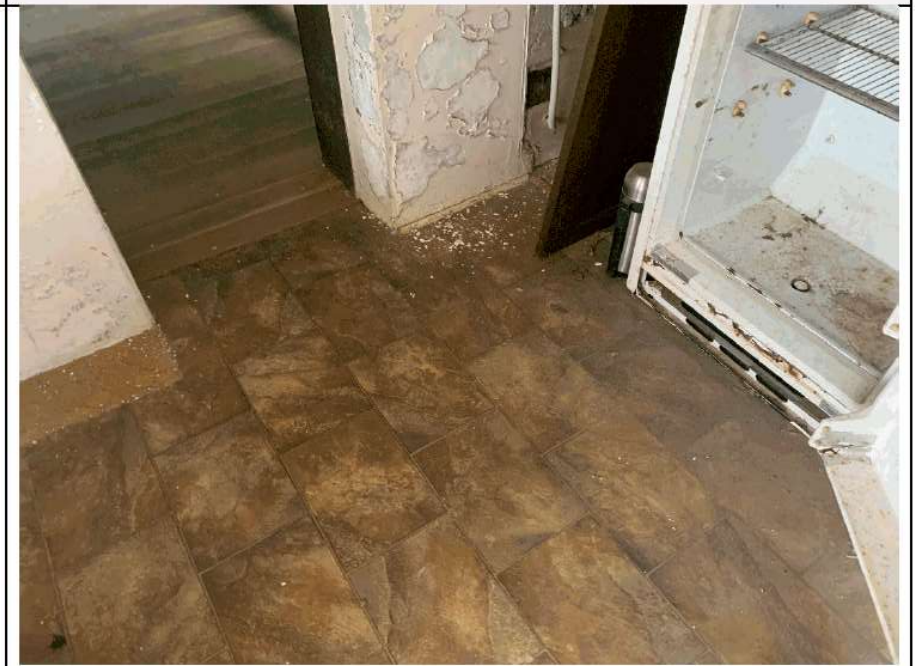
Photo 6 (Adhesive to vinyl sheeting, below vinyl sheeting)

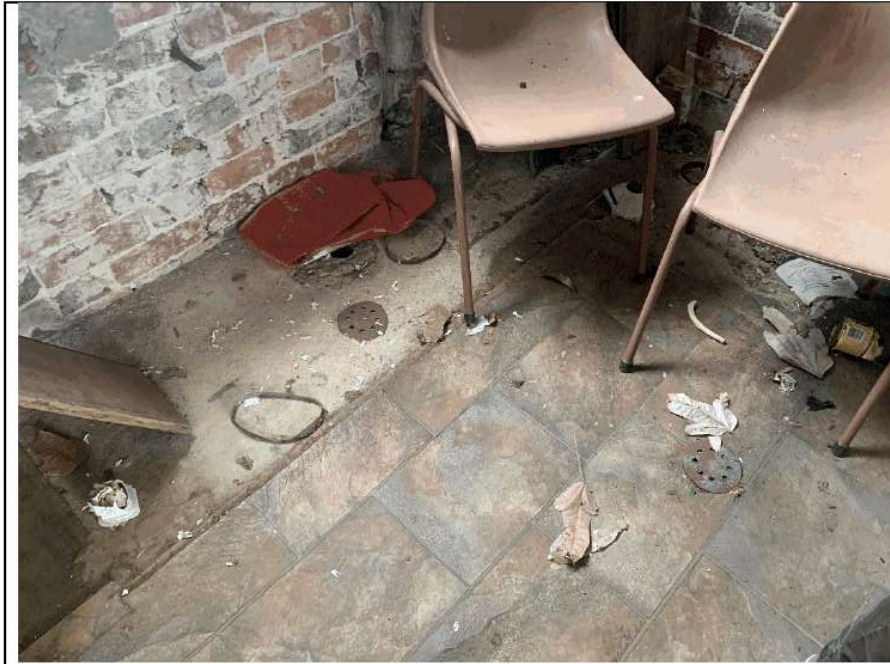
Photo 7 (Adhesive to vinyl sheeting, below vinyl sheeting)

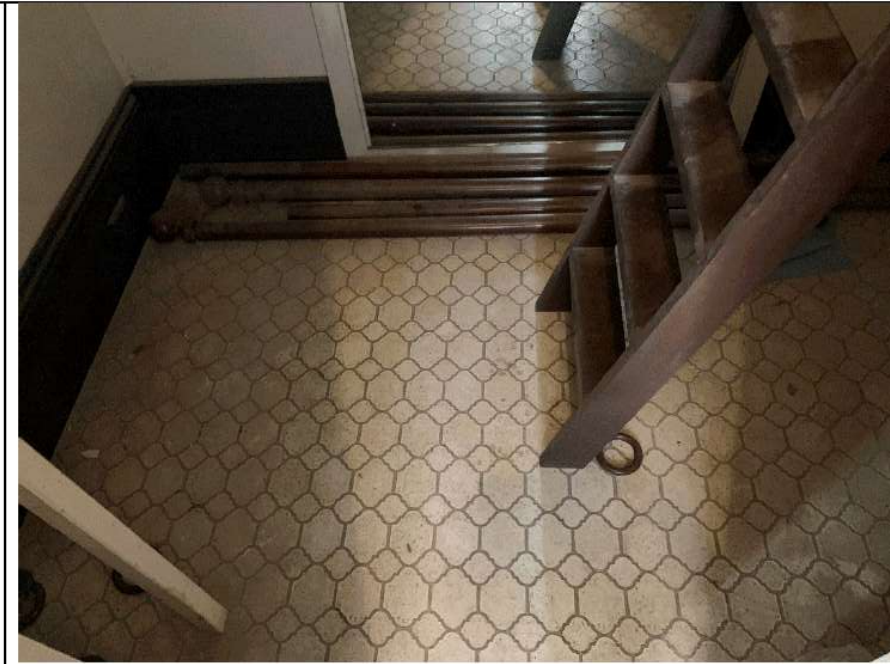
Photo 8 (Adhesive to vinyl sheeting, below vinyl sheeting)
